Artifacts, Pitfalls and Normal Variants

Ivica Zalud, Frederico Rocha

The objective of this article is to describe and illustrate many of the ultrasound artifacts commonly encountered in obstetrical and gynecological ultrasound including Doppler and 3D imaging artifacts.

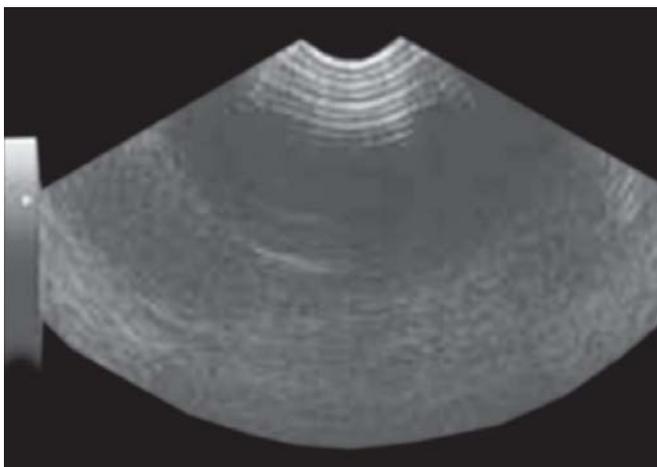
Fig. 1: Reverberation: Anterior wall of the urinary bladder in an obese person

Reverberation results in reflectors that are not real, being placed on the image. They will be placed behind the second real reflector at separation intervals equal to the separation between the first and second real reflectors. Each subsequent reflection will be weaker than prior ones. This can occur from the anterior wall of the urinary bladder, especially in an obese person (Fig. 1). The sound pulse is reflected back from the anterior wall of the bladder to the transducer face. As the transducer has to produce the true echo, it absorbs some of the pulse. However, some of that sound is reflected from the transducer-skin interface back into the body. It again hits the anterior bladder interface and is reflected back for a second time to the transducer. This produces a first reverberation artifact on the image. The ultrasound equipment assumes (incorrectly) that the signal has returned from a point in the body that is twice the distance from the transducer, as it is aware only of the time taken for the signal to return and not of the path actually travelled. This artifact is seen as a blip on the screen at twice the depth of the true echo. This is because the time taken for the first reverberation artifact is the same time taken for the pulse to

travel the original distance and back. This same reverberation can occur a second and third time to give the second or third reverberation artifact. This is commonly known as 'near-field' artifact, especially in obese patients. The echoes may be more diffuse and fuzzy if they bounce around in various directions in the subcutaneous fat before returning to the transducer.¹ Occasionally, care must be taken not to confuse this artifact for an anterior placenta.

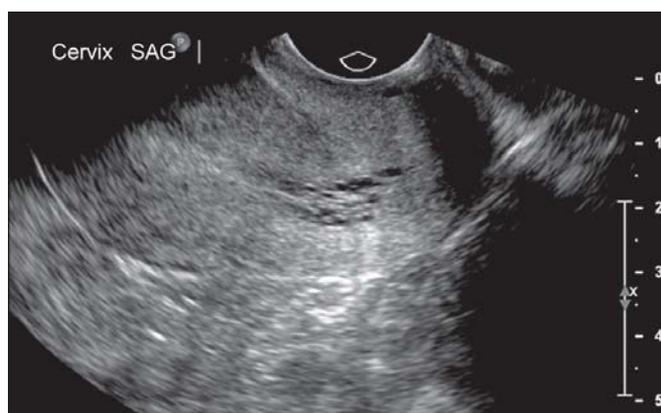
Fig. 2: Shadowing artifacts on transvaginal ultrasound caused by air in the condom. Portion of the cervix and *cul-de-sac* are 'in the dark'

Air can also cause shadowing (Figs 2 and 3). Most of the time, this causes great interference on the ultrasound examination by obscuring the deeper structures. For this reason, patients have to be examined with a full bladder to displace the air-containing bowel from the pelvis. The shadow deep to gas is different from the shadow deep to a calcified structure. With the latter, although some of the sound is reflected, much of it is absorbed. With gas, the acoustic mismatch is so great that virtually all of the sound is reflected. This sound bounces around in the tissues between the transducer and the gas, and can cause numerous reverberations and other mirror image artifacts, which on the image appear deep to the echo from the gas interface. This has been called a 'dirty' shadow as opposed to the 'clean' shadow deep to bone or other calcified

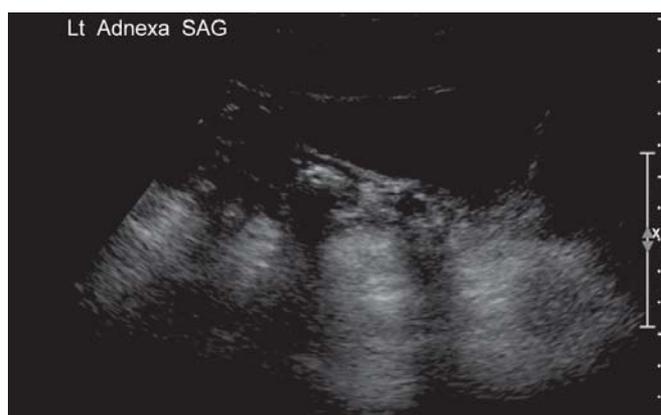
Fig. 3: Another example of shadowing caused by air in the bowels

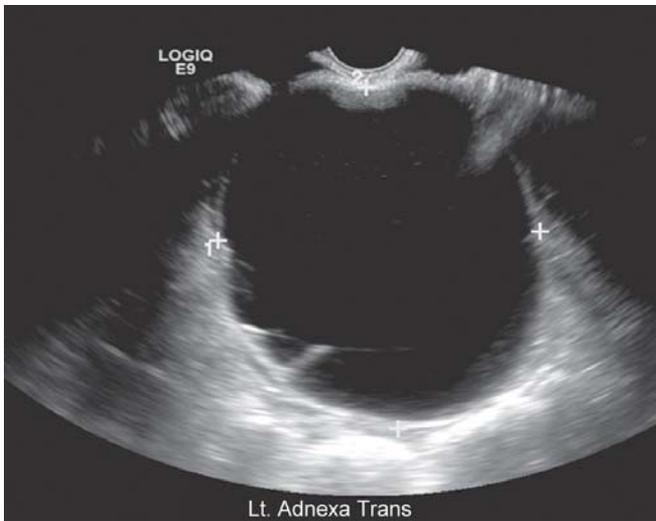
Fig. 4: Enhancement: The echoes returning from structures deep to the cyst appear more intense than if the ovarian cyst was not interposed

Enhancement is the opposite of shadowing. It is the increase in reflection amplitude from reflectors that lie behind a weakly attenuating structure (Figs 4 and 5). Shadowing and enhancement result in reflectors being placed on the image with amplitudes that are too low and too high, respectively. In this situation, the echoes returning from structures deep to cysts appear more intense than if the cyst were not interposed. There are two explanations for this phenomenon. One is that the fluid replaces normal soft tissue in the intervening space, decreasing its attenuation.³ The time gain compensation (TGC) is set to expect tissue between the transducer and the deepest echoes. If there is fluid instead, especially if the fluid occupies only the central portion of the image, the echoes returning from deep to the fluid collection will be more intense than expected.³ This appears as a posterior enhancement of the beam and this finding indicates that a lesion is truly cystic, even if there are internal echoes within the cyst. Occasionally, enhancement will be

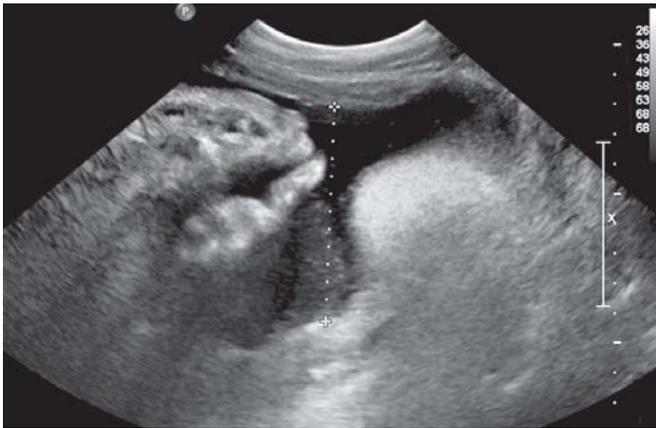
Fig. 5: Enhancement caused by amniotic fluid. Bright edges are clearly seen

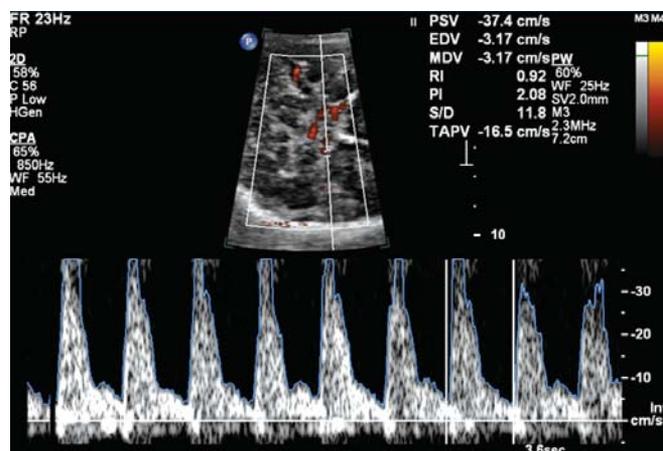
Fig. 6: Aliasing: Higher pulse repetition frequencies (PRF) permit higher Doppler shifts to be detected but also increase the chance of the range ambiguity artifact

Aliasing is the most common artifact encountered in Doppler ultrasound.⁷ There is an upper limit to Doppler shift that can be detected by pulsed instruments. If the Doppler shift frequency exceeds one half the pulse repetition frequency (normally in the 1–30 kHz range), aliasing occurs and improper Doppler shift information (improper direction and improper value) results. Higher pulse repetition frequencies permit higher Doppler shifts to be detected but also increase the chance of the range ambiguity artifact (Figs 6 and 7). Aliasing in a color flow system is exposed in a spatial two-dimensional plane in which the aliased flow is shown in reversed color surrounded by non-aliased flow (Fig. 8). This pattern mimics the color flow appearance of separate streams in differing directions. The two patterns are, however, clearly distinguishable. In an aliased flow, the higher velocity generates a higher Doppler shifted frequency that is depicted with greater brightness. The higher the frequency shifts, the brighter the color. The brightest level in the color calibration bar (the uppermost for the flow toward the transducer and lowermost for the flow away from the transducer) represents the Nyquist limit. As the velocity and therefore, the frequency shift exceeds this limit, the color wraps around the calibration bar and appears at the other end as the most luminous color of the opposite direction. For example, a flow toward the transducer with an increasing velocity is depicted with an

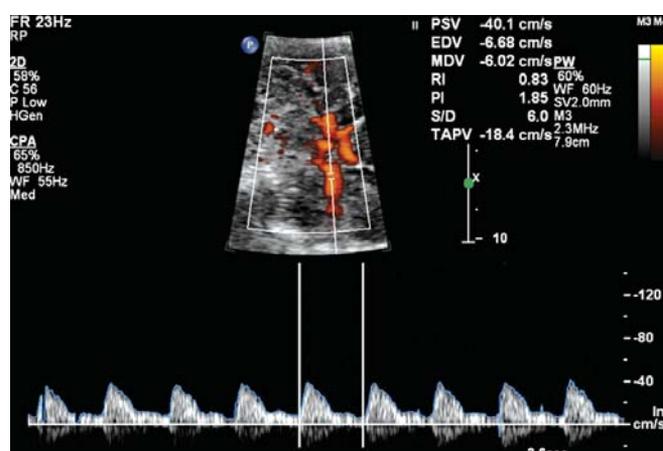
Fig. 7: Appropriate PRF setting to avoid aliasing in pulsed Doppler waveform analysis

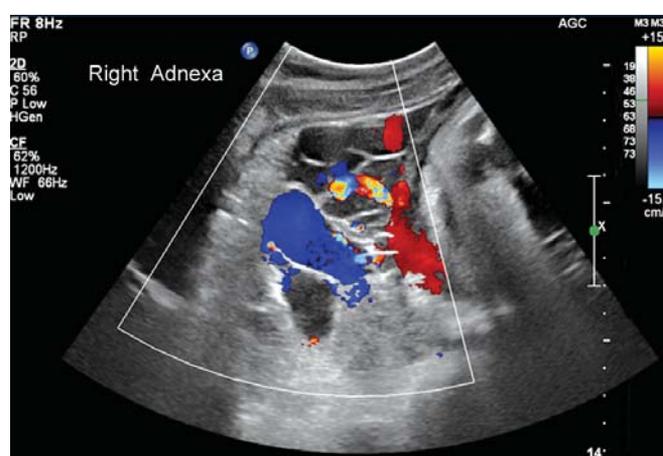
Fig. 8: Right complex, mostly cystic adnexal mass. Color Doppler aliasing shown in the middle of the mass (neovascularization) with normal red (uterine vein) and blue color (internal iliac vein) displayed on side

increasingly bright red color changing to yellow. As the Nyquist limit is reached, the color flow shows brightest yellow in the color bar and as the limit exceeds, flow is shown in the brightest blue. Thus, in an aliased flow, bright or pale color of one direction is juxtaposed against bright

color of the opposite direction. In contrast, in genuine flow separation the distinct flow streams are depicted in the directionally appropriate colors that are separated by a dark margin. It should be noted that the hue that demarcates an aliased flow would depend on the choice of the color-mapping scheme.

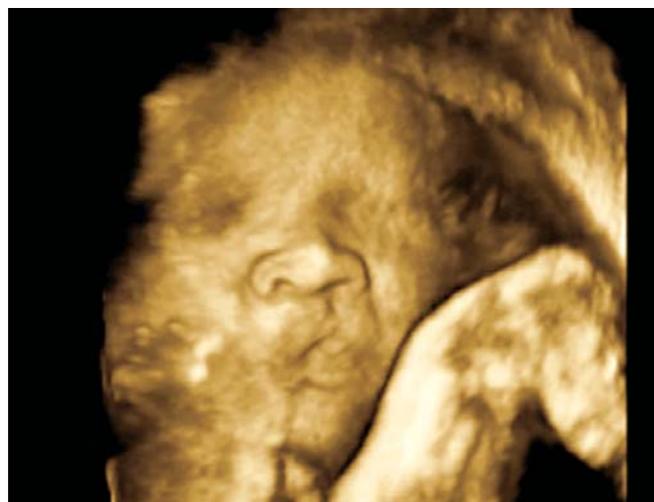
Fig. 10: 3D artifact: Shadowing from adjacent structures reproduced an apparent cleft lip and palate

Three-dimensional (3D) ultrasonography is a rapidly developing area with increased application in obstetrics and gynecology. Unfortunately, its technology is not only susceptible to artifacts, but the volume acquisition also can present unique artifacts. The images obtained are usually acquired by a series of 2D image planes that are rendered to a volume 3D image. Motion or vibration of the targeted organ during the acquisition of a volume introduces a motion artifact into the volume. The motion artifact affects the overall quality of a volume and is particularly relevant in obstetric imaging because of the movement of the fetus.¹¹ Shadowing from adjacent structures can reproduce, for example, an apparent limb defect or cleft lip and palate (Fig. 10).¹²

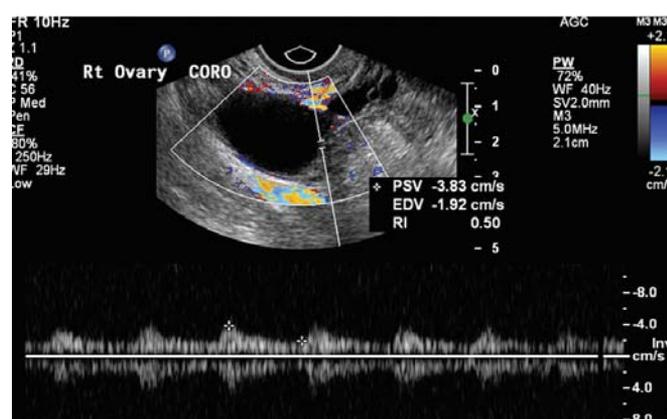
Fig. 9: Mirror effect: A mirror image of a Doppler spectrum appeared on the opposite side of the baseline when blood flow was unidirectional and should appear only on one side of the baseline

side of a strong reflector (such as a bone). The duplicated vessel containing flow could be misinterpreted as an additional vessel. It will have a spectrum similar to that for the real vessel (Fig. 9). A mirror image of a Doppler spectrum can appear on the opposite side of the baseline when, indeed, flow is unidirectional and should appear only on one side of the baseline.¹⁰ This is an electronic duplication of the spectral information. It can occur when receiver gain is set too high (causing overloading in the receiver and cross talk between the two flow channels) or with low gain (where the receiver has difficulty determining the sign of the Doppler shift). It can also occur when Doppler angle is near 90°. Here the duplication is usually legitimate and this is because beams are focused and not cylindrical in shape. Thus, portions of the beam can experience flow toward while other portions can experience flow away.
